Histologic Findings within Peri-implant Soft Tissue in Failed Implants Secondary to Excess Cement

Report of Two Cases and Review of Literature

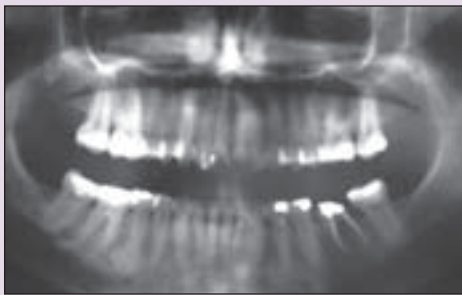
Figure 1A. Case One preoperative radiograph. Taken in June 2009 of endodontically failed tooth #19.

In June 2009, a 44-year-old female in good general health was referred by her general dentist to an oral and maxillofacial surgeon for extraction of the mandibular left first molar (#19) (Figure 1A). The treatment plan was to extract tooth #19 and immediately place a dental implant. After local anesthesia was obtained, the tooth was atraumatically extracted. The surgical site revealed an inadequate amount of alveolar bone for the planned procedure and, thus, the decision was made to place freeze-dried human bone graft material (*OraGraft*; *Life Net Health*) in the extraction socket and postpone placement of a dental implant for several months.

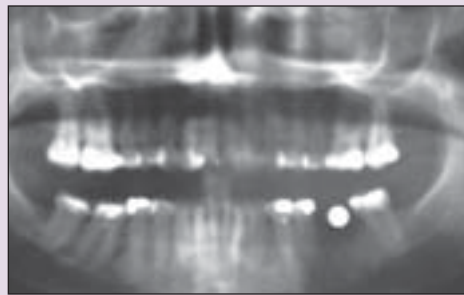
Figure 1B. Post-extraction radiograph with replacement bone graft of edentulous #19 area left mandible. Radiograph taken March 2010.

The patient returned to the office in March 2010 for evaluation of the previously placed graft in the edentulous area of tooth #19 and implant consultation (Figure 1B). The patient was ad-

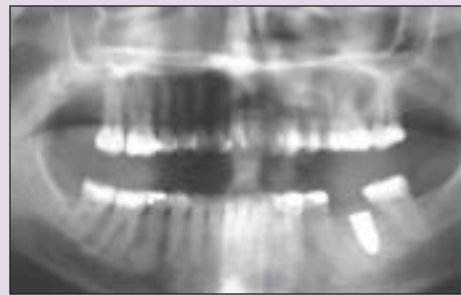
Figure 1C. Post-insertion radiograph taken Aug. 26, 2010, of Nobel Biocare replace select screw implant.

vised to wait an additional six months. On August 26, 2010, the patient returned to the oral and maxillofacial surgeon for implant placement. A Nobel Biocare replace select implant (*Nobel Biocare; Yorba Linda, CA*) was inserted (Figure 1C) in the edentulous space #19. The implant was allowed to heal for four months. In December 2010, the patient returned to her general dentist for restoration of the implant. A ceramo-metal crown was subsequently fabricated and cemented.

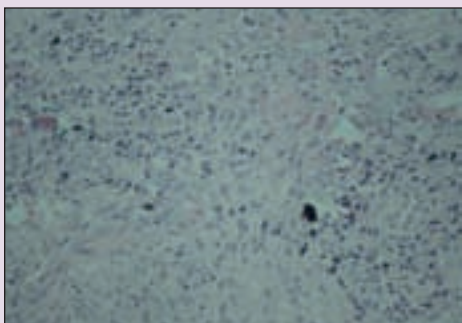
Figure 1D. Hematoxylin and eosin-stained section (20x magnification) demonstrating multiple foci of black exogenous cement deposits in several areas. Stroma is highly vascularized fibrous tissue and contains scattered acute and chronic inflammatory cells.

Hematoxylin and eosin-stained sections of the specimen (Figure 1D) revealed foci of black amorphous exogenous cement scattered throughout the fibrous stroma. These foci were accompanied by an acute and chronic inflammatory cell infiltrate and multinucleated foreign body type giant cells (Figure 1E). Surface mucosa overlying inflamed fibrous tissue containing a spicule of residual necrotic bone (Figure 1F) was also noted. The final pathology report included a diagnosis of acute and chronic inflammatory reaction with foci of exogenous matter consistent with cement. The ICD-9 code for foreign body granuloma accompanied the diagnosis.

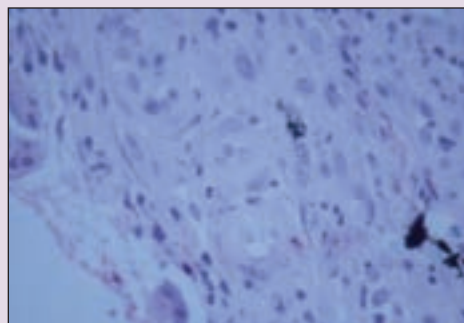
Figure 1E. Hematoxylin and eosin-stained section (40x magnification) demonstrates multinucleated giant cells and foci of black cement particles within fibrous tissue stroma. Scattered inflammatory cells are also noted.

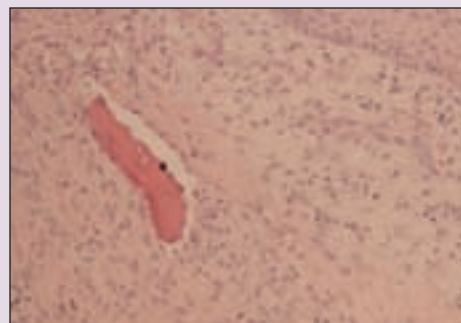
Figure 1F. Hematoxylin and eosin-stained section (10x magnification) shows squamous surface mucosa overlying inflamed fibrous tissue and spicule of residual necrotic bone.

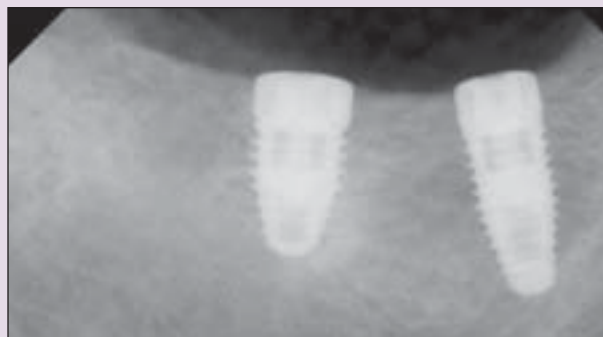
Figure 2A. Case Two radiograph taken January 2006 following insertion of screw dental implants #29 and #31.

In January 2006, a 57-year-old male presented to an oral and maxillofacial surgeon. He had been referred by his general dentist for placement of dental implants in the edentulous right mandible. Two implants (*Nobel Biocare replace select*) were placed in the edentulous right mandible in the area of the second premolar and second molar sites (Figure 2A).

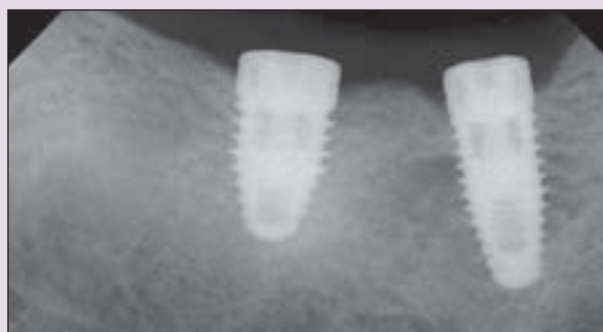
Figure 2B. Radiograph taken before prosthetics; April 2006.

Four months after the implants were placed they were evaluated for clinical integration (Figure 2B). The patient returned to the general dentist for fabrication of abutment crown restorations. Individual ceramo-metal crowns were fabricated and cemented onto the implants.

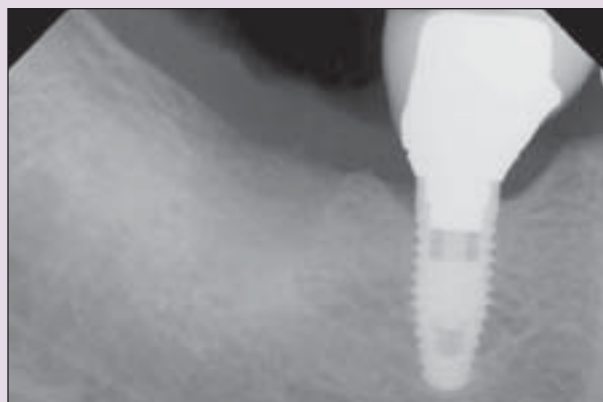
On October 26, 2011, the patient presented with excessive bone loss around a failing implant at the mandibular second molar site. This implant was removed, along with the hyperplastic soft tissue surrounding the failed implant, which was placed in a bottle of 10% formalin and sent to the oral and maxillofacial pathology laboratory for histopathologic examination. A bone graft using a mineralized allograft material (*Puros; Zimmer Dental, Warsaw, IN*) was placed in the surgical defect (Figure 2C) for a future implant.

Figure 2C. radiograph taken October 2011 following removal of failed implant #31 and replacement bone graft for future implant.

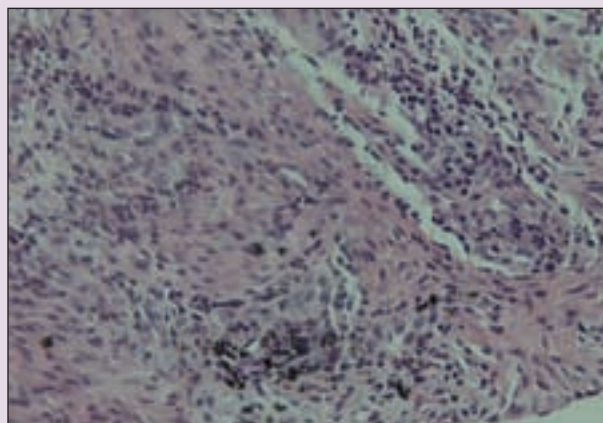
Hematoxylin and eosin-stained sections of the tissue (Figure 2D) showed scattered foci of black particulate exogenous cement material throughout the inflamed fibrous tissue stroma. The final pathology report included a diagnosis of acute and chronic inflammatory reaction, with foci of exogenous matter, consistent with cement, and ICD-9 coded for foreign body granuloma.

Figure 2D. Hematoxylin and eosin-stained section (20x magnification) depicts highly vascularized fibrous tissue containing several foci of black exogenous cement particles and scattered acute and chronic inflammatory cells in stroma.
